National Highway-Rail Grade Crossing Safety Conference

Section 130 Program Case Studies Presentation

Atlas Technical Consultants

21 August 2024

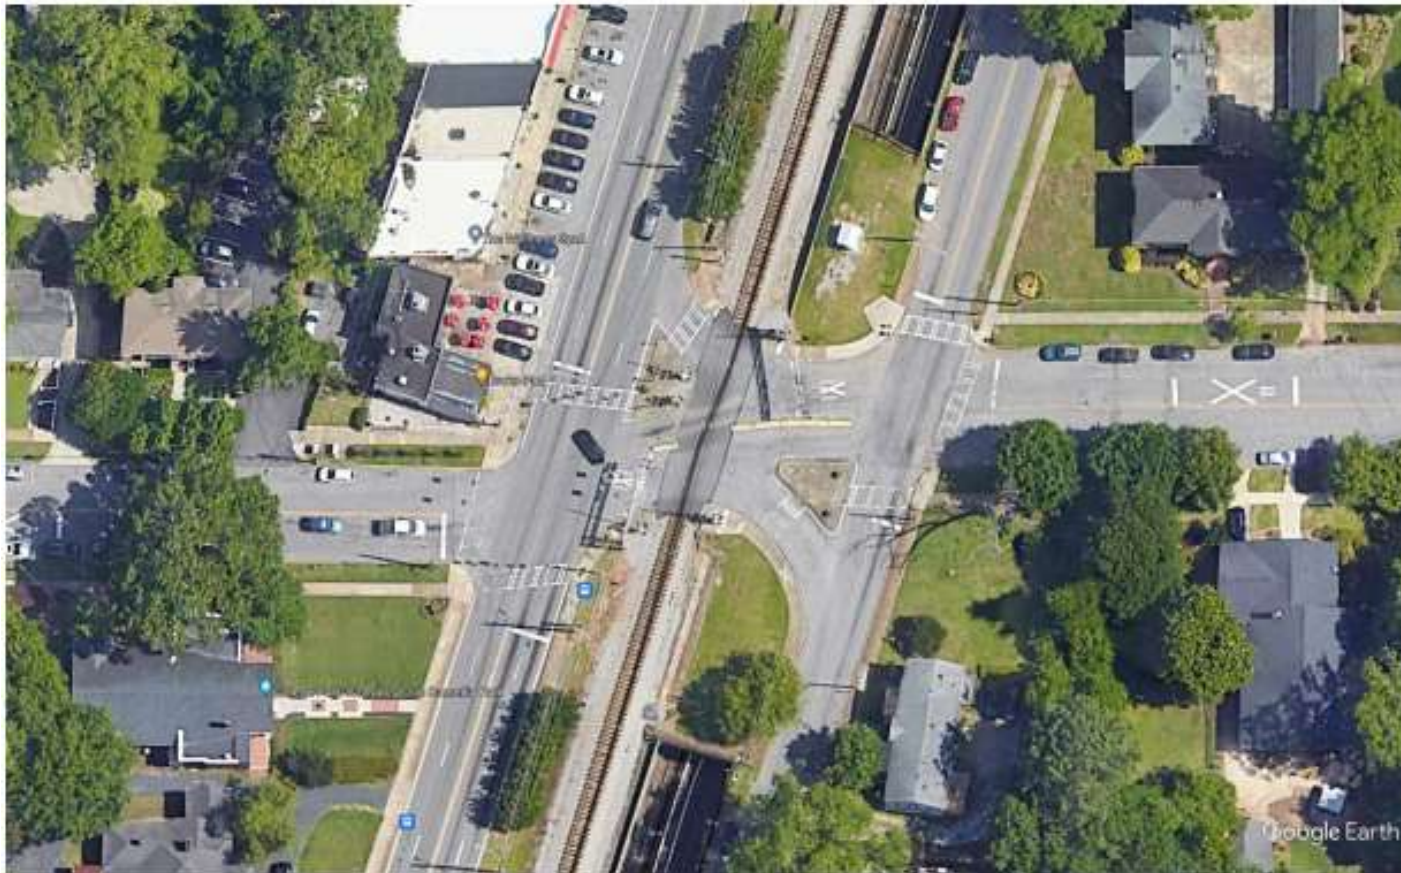
Prompt Action - 050330S Rugby Avenue

- First report - May 2023 FRA report received 6/5/2023
- 5/25/2023 and 3/2/2023 “trapped on crossing”
- Advance pre-emption, outdated signal faces/phasing
(no protected left track clearance green and opposing yellow trap)
- Diagnostic Team Review scheduled 6/16/2024 for 7/17/2024
- Grave pre-emption phasing defect identified and corrected

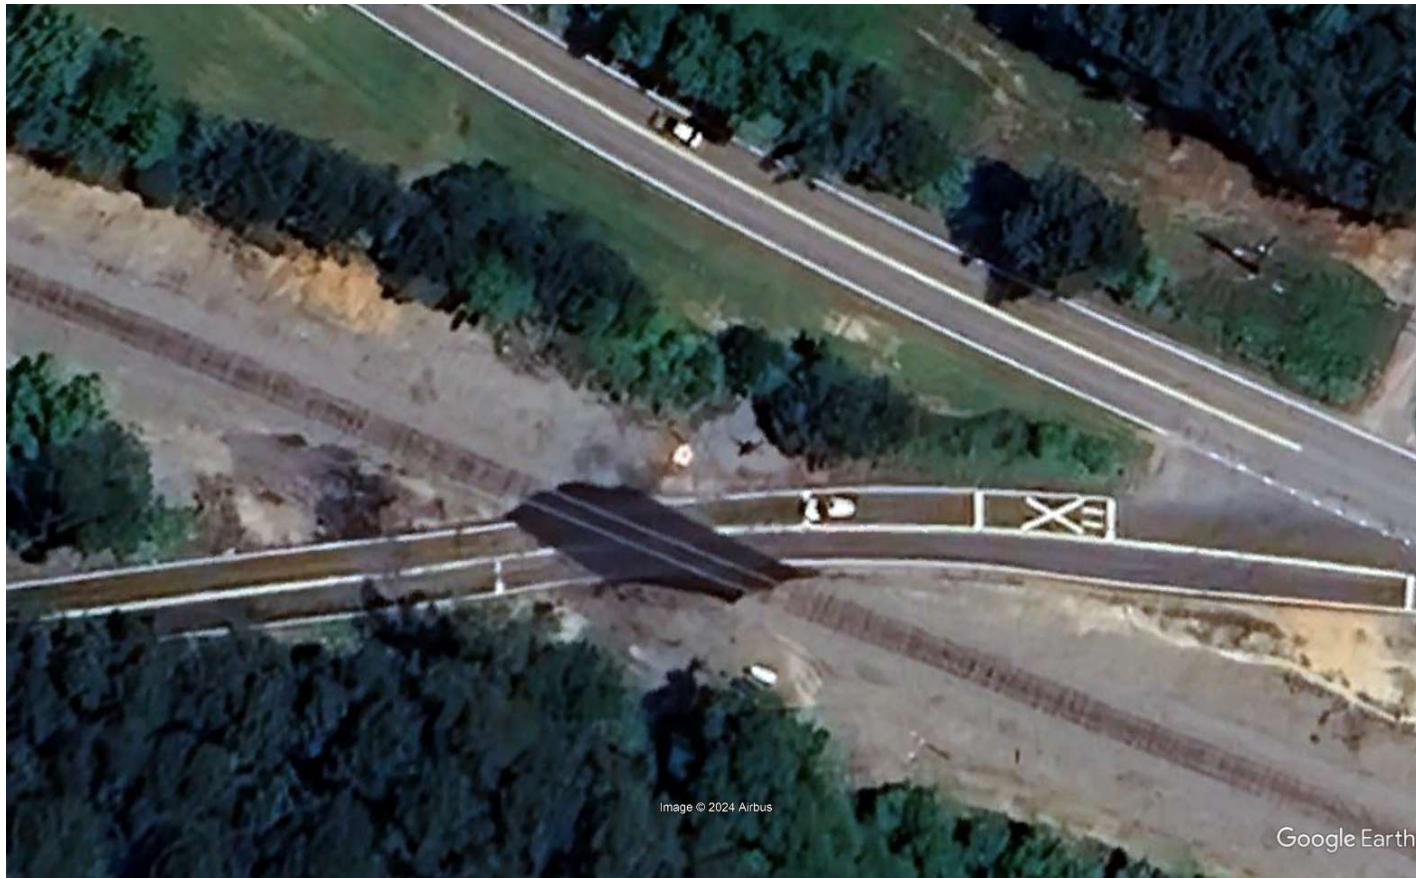
719820N Angham Road

- Multiple crashes 2018-2021, “unoccupied” autos, 9pm - 4am
- Driving off pavement edge near crossing or edge of crossing surface and becoming stuck
- Synergistic hazards
 - Far side pavement not visible because of crest
 - Horizontal alignment change at crossing
 - Skew
- Delineators installed in February 2021

- 2/28/2024 and 3/3/2024 unoccupied vehicles
- 4/06/2024 truck with horse trailer drove around gates
- Additional Mitigation
 - Restore of center and edge lines after crossing T&S (relatively long distance along travelled way at crossing)
 - Add streetlights
 - Larger ENS signs with placard
 - Closer spaced center line RPMs and add edge line RPMS
 - Pavement widening or paved shoulders adjacent to crossing surface
 - Possible GDOT-City RCE grant

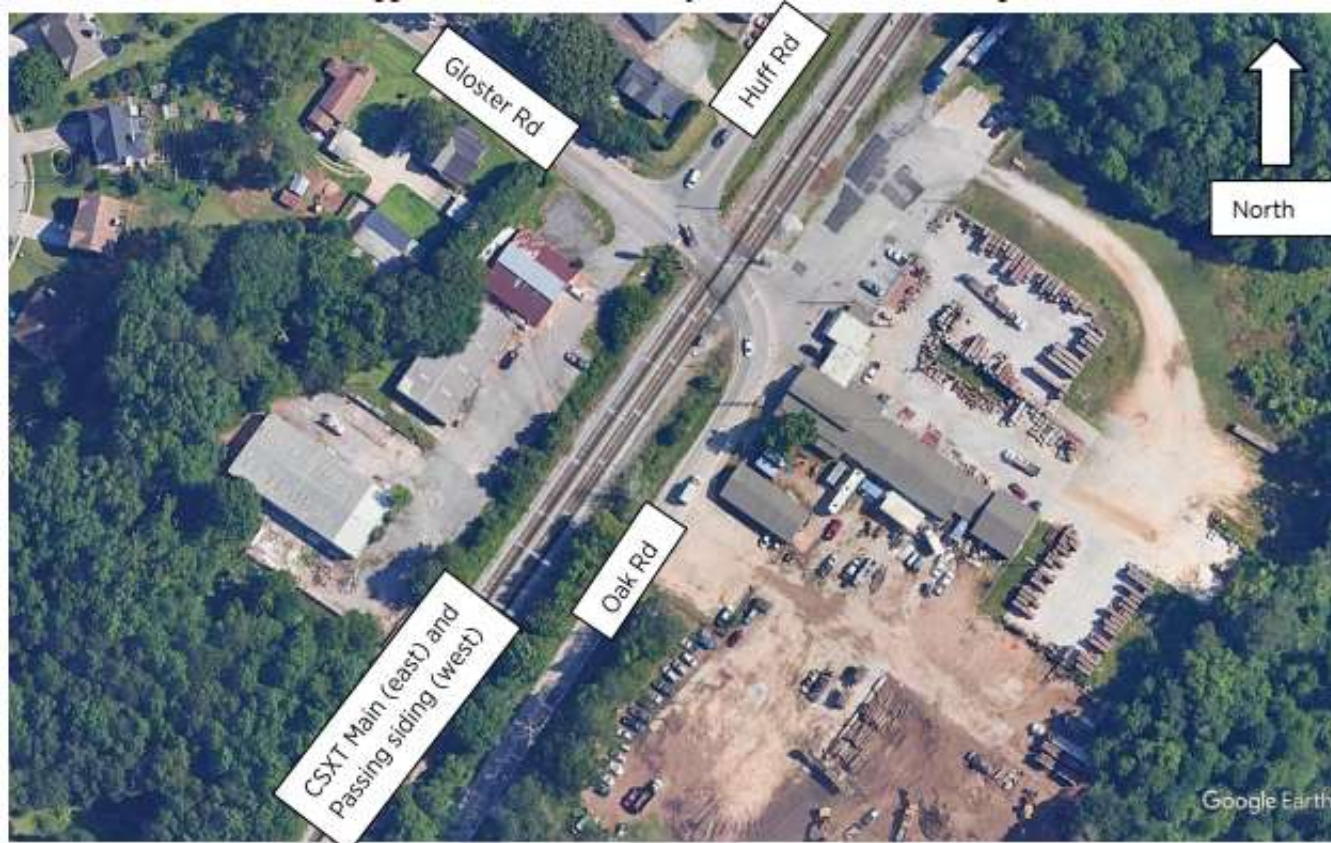
639789H Gloster – Oak Road

- Six crashes 2017-2021
 - Two motorists turned onto track
 - Two motorists drove through gate
 - Damaged vehicle came to rest on track after adjacent intersection wreck
 - Motorist drove off edge of wet pavement
- Eight crashes and seven crashes 1977-2015
 - 13 of 14 crashes when dark, 9 crashes 11:45pm-3:05am
 - All crashes were autos, pick up trucks, or vans
- 2021 Diagnostic Team Findings
 - Excessive vehicular speed entering curve (& superelevation running off at crossing)
 - Brickyard/aggregate supplier paved parking conceals curve
 - Darkness, especially late hours

- 2021 Diagnostic Team-identified Mitigation
 - Crossing signal relocation for recovery and visibility
 - Speed limit reduction 40 mph to 35 mph
 - Center and edge lines – increase from 5 inch to 8 inch
 - Raised pavement markers – doubled up at 10 feet spacing and along edgeline
 - Curve and intersection signing improvement
 - Chevrons
 - Other mitigation not implemented
 - Rumble strips
 - Speed bump or speed table
 - Speed indication or actuated warning lights

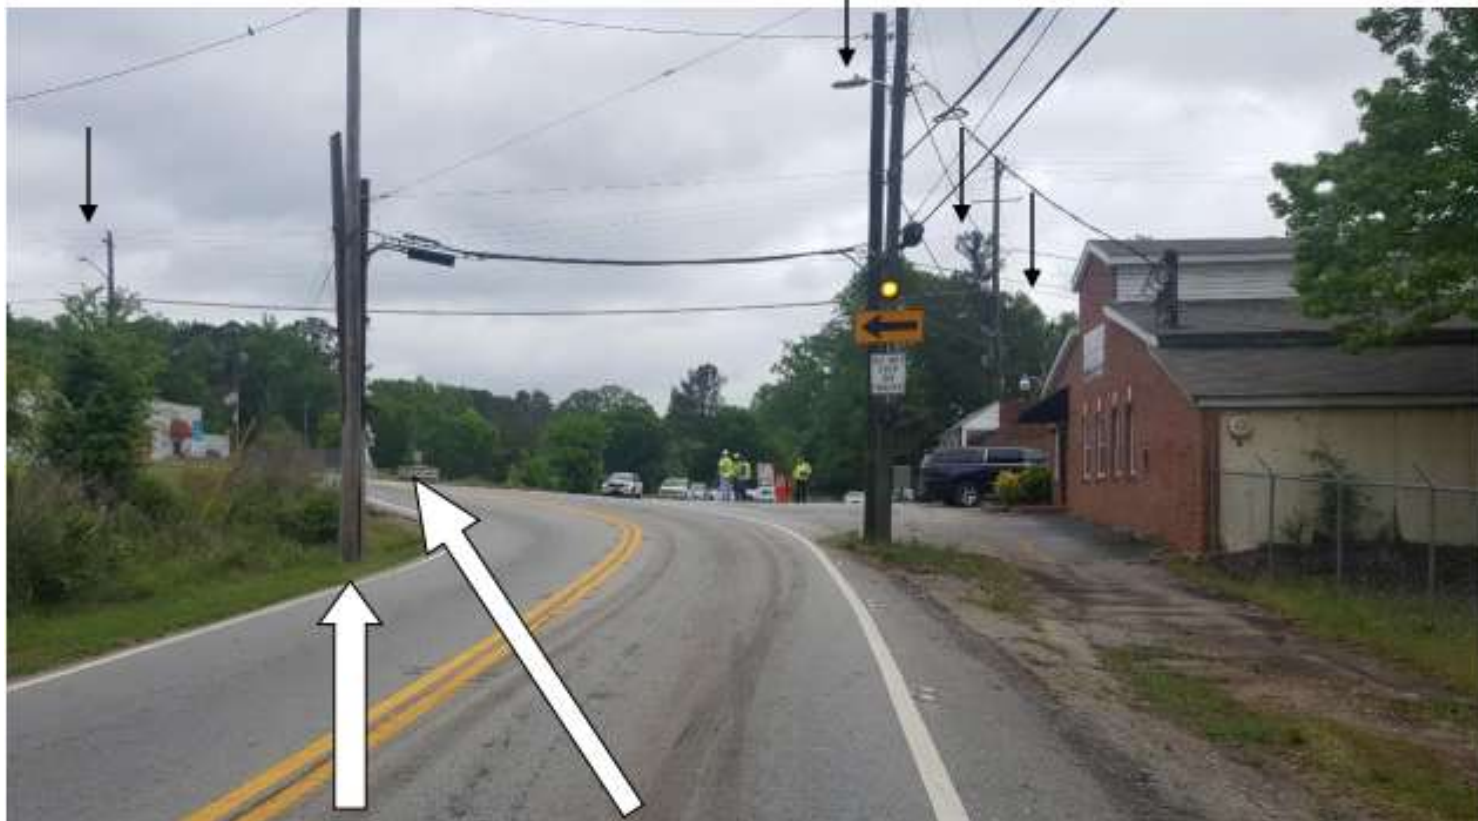
639789H Gloster – Oak Road

Crossing signal obstructed by utility pole. New crossing signal location will improve pre-view.

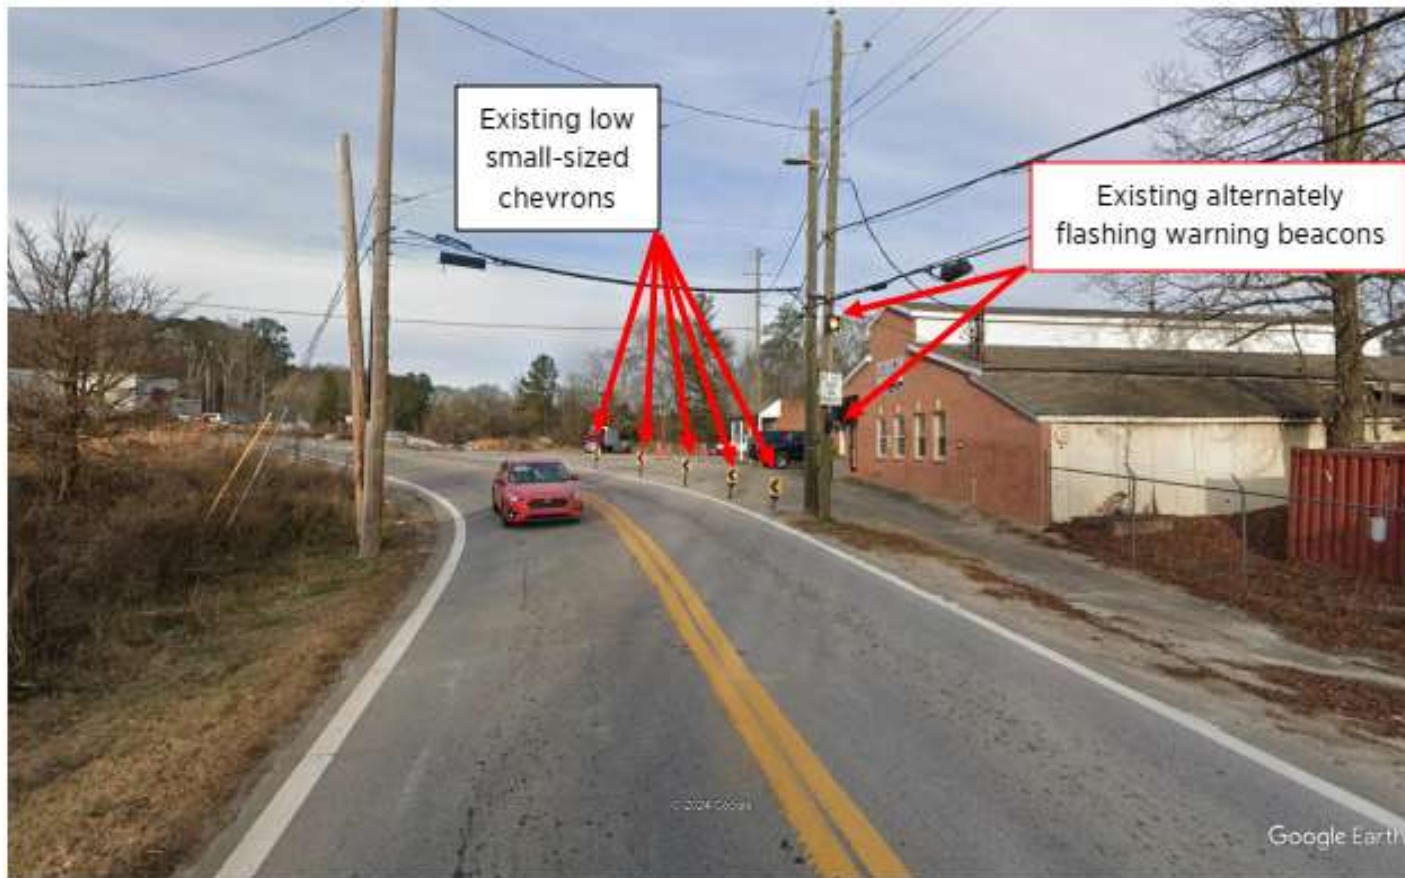
639789H Gloster – Oak Road

- Recent crashes since 2021 improvements
 - Three crashes 12:40-4:30am, one a gate drive-around
 - *Two vehicles stuck on track without being struck*
 - *Three signal knockdowns without vehicle being struck*
 - *Realign gate mechanism struck by vehicle*
- 2024 Follow up Diagnostic Team Meeting
 - Press for rumble strips and/or approaching vehicle actuated warning
 - Larger ENS
