**Diagnostic Team
Best Practices**

What is a Diagnostic Team?

Case Studies

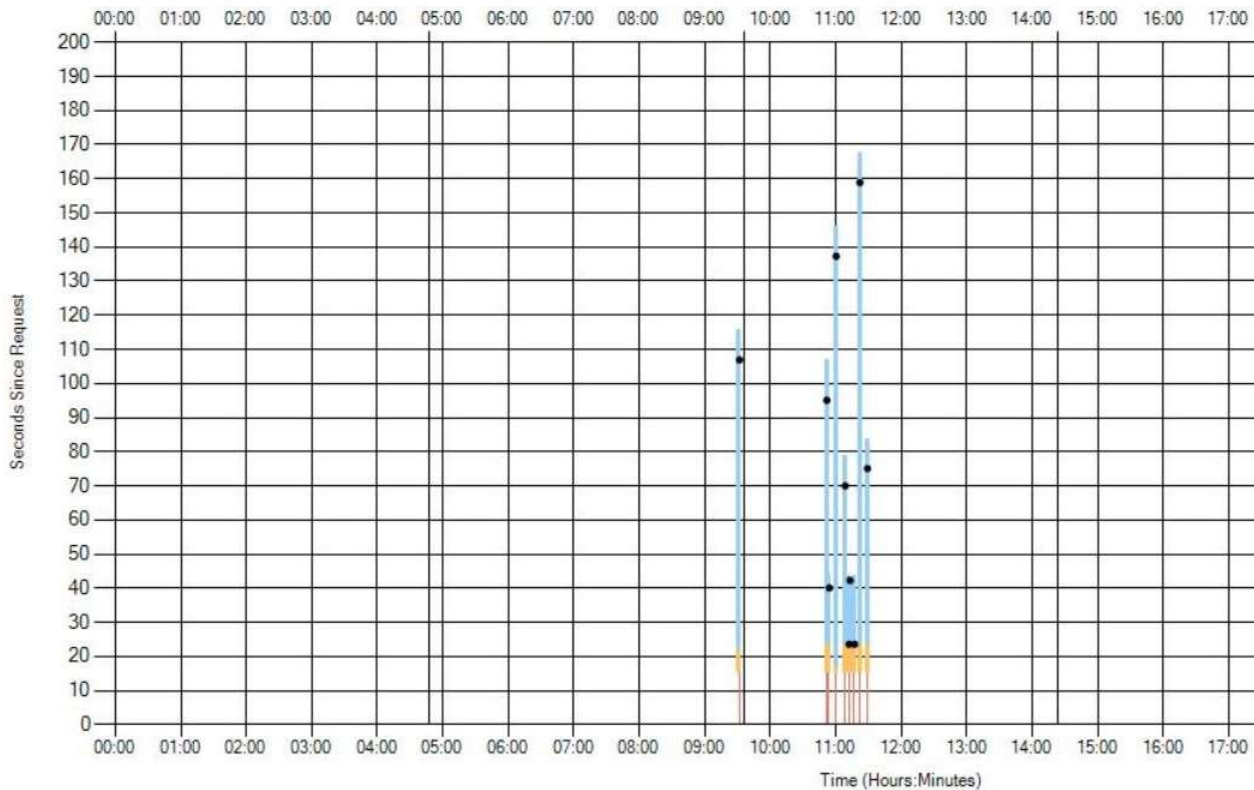
Preemption Details

Geneva Rd. @ 200 S (Lindon) - SIG#6057
Wednesday, September 20, 2023 12:00 AM - Thursday, September 21, 2023 12:00 AM

Preempt Number: 1

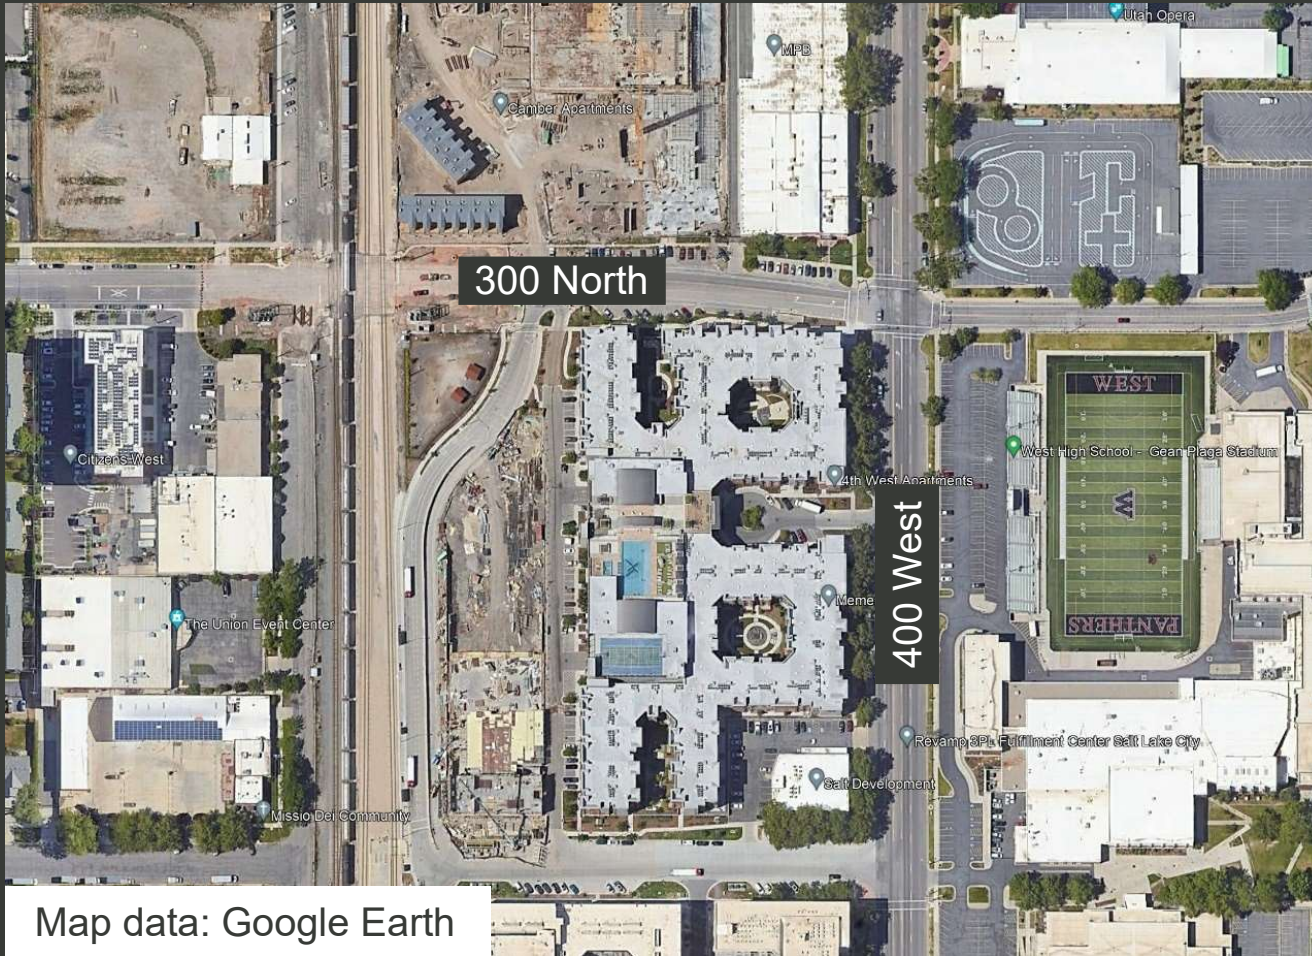
300 North Salt Lake City

- Frequent reports of kids climbing between stopped train cars
- AADT: 2,025

- Daily Trains: 145
- Max Train Speed: 79 mph
- Unsafe Pedestrian Reports: 12
- Pedestrian fatality in 2015

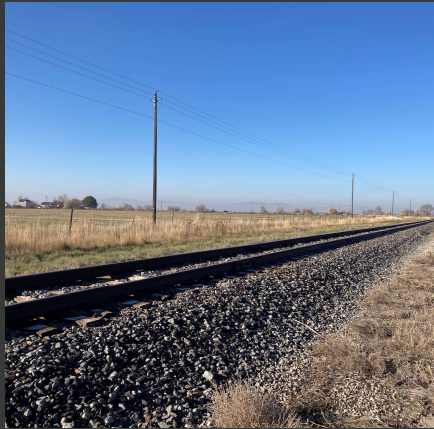
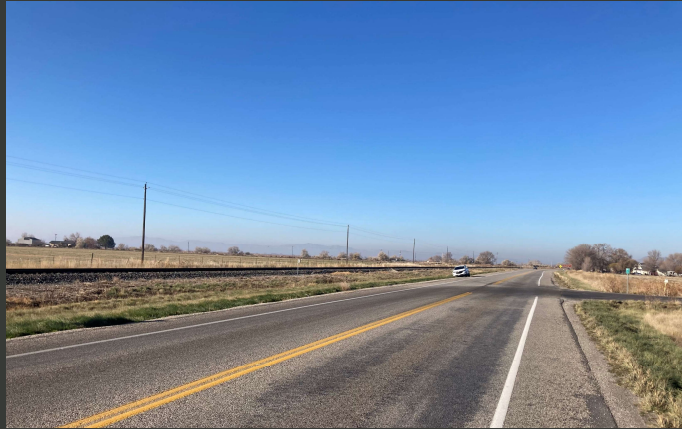
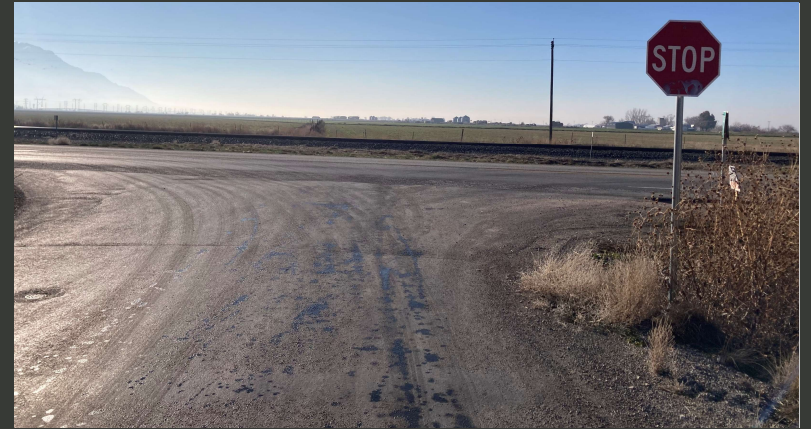
Crossing Relocation

2600 W to 2400 W
Brigham City

Crossing Data

Highway Data

- AADT (Existing): 400
- AADT (New): Based on development, zoned industrial
- Large Trucks Anticipated
- <75 ft of storage downstream of the crossing

Railroad Data – 5 Years

- Daily Trains: 4
- Max Train Speed: 10 mph
- Unsafe Motorist Reports: 0
- FRA Reportable Incidents: None in last 10 years

- NOTES:**
1. INSTALL STORAGE SPACE SIGN W10-11A "58 FEET BETWEEN TRACKS AND HIGHWAY"
 2. INSTALL WARNING SIGN R8-8 "DO NOT STOP ON TRACKS"
 3. INSTALL TRAFFIC SIGN RS12-10 "NO VEHICLES TOWING TRAILERS IN LEFT LANE"
 4. ALL LANES ARE 12' TRAVEL LANES
 5. ESTIMATED TRAFFIC COUNT FOR THE RELOCATED CROSSING IS 400 AADT.

How would you address the short storage distance?

- A. Install a Do Not Stop on Tracks (R8-8) Sign
- B. Install Storage Distance (W10-11, W10-11a) Signs
- C. Install a traffic signal with preemption
- D. Install a free right-turn and an acceleration lane

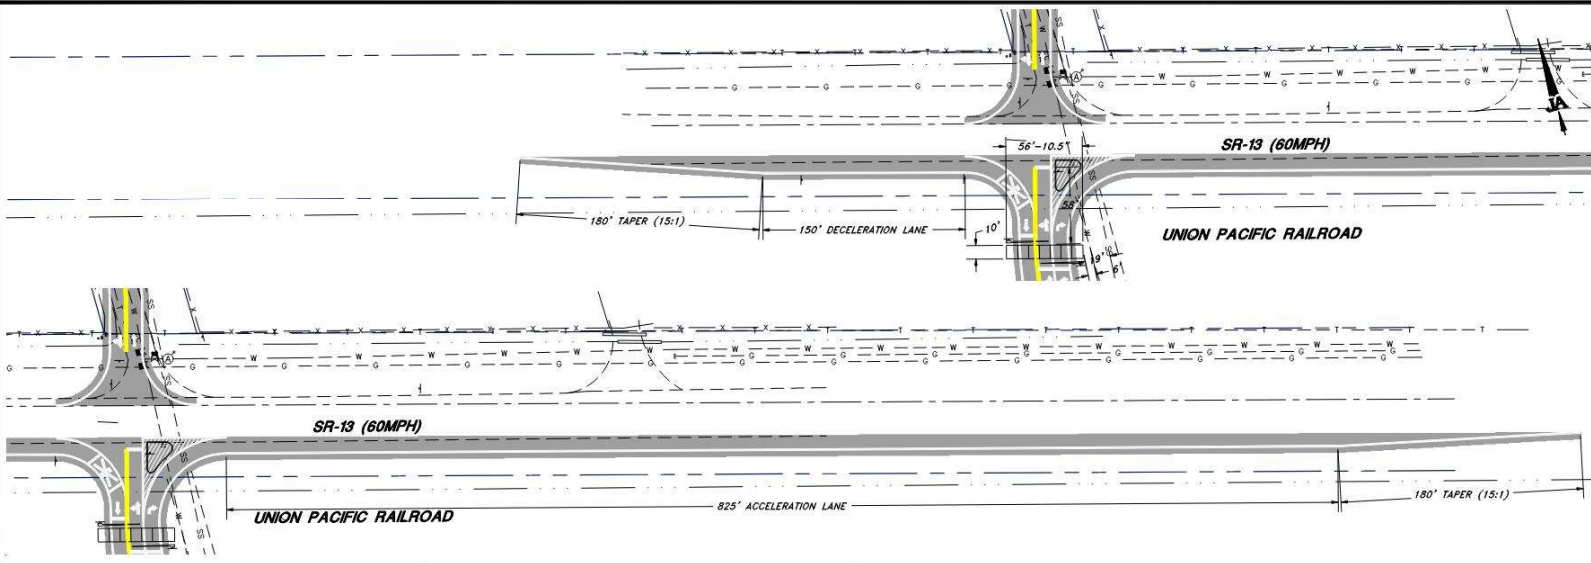
SITE PLAN

CONCRETE PANELS, PRE-CAST (6"x8 1/2"x10")	7	EA.
WOOD TIES, (7"x9"x10")	46	EA.
RAIL	155	L.F.
BALLAST	770	C.F.
SUB BALLAST	356	C.F.
TORX SCREWS, FOR WOOD TIES (3/4"x12")	126	EA.
ELASTOMERIC BEARING PADS	56	EA.
RING LIFTING DEVICE	1	EA.
GEOWEB UNDERLAYMENT	855	S.F.
GEOTEXTILE FABRIC	950	S.F.
PERFORATED DRAINAGE PIPE (6")	125	L.F.

2400 WEST AND SR-13 INTERSECTION PROJECT

INTERCONNECTED RAILROAD CROSSING

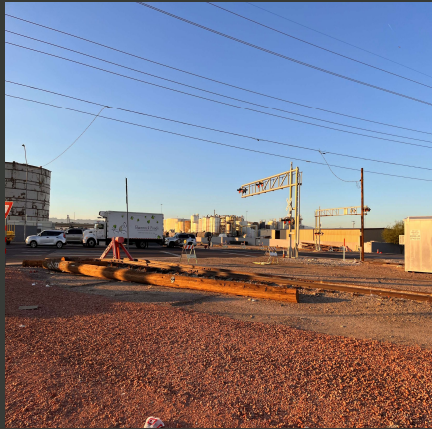
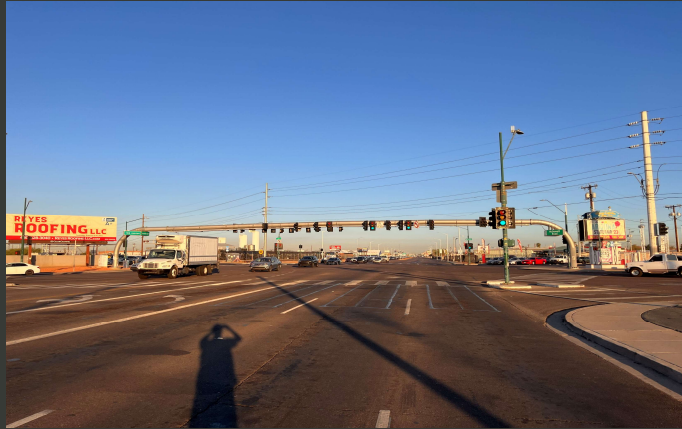
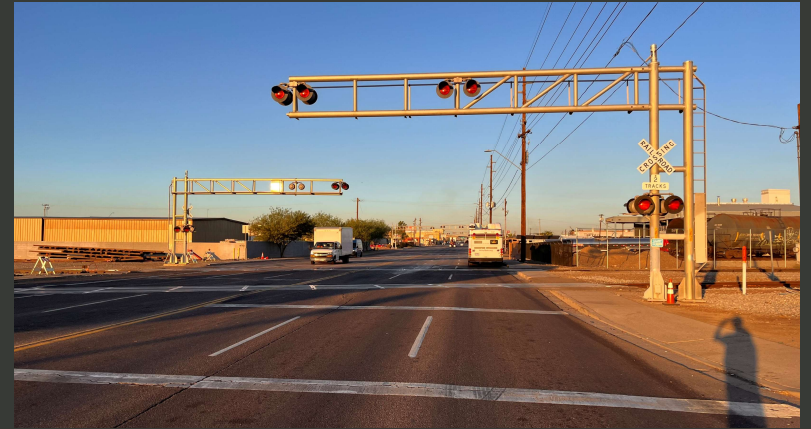
Crossing Upgrades

19th Ave/ McDowell Rd
Phoenix, AZ

Crossing Data

Highway Data

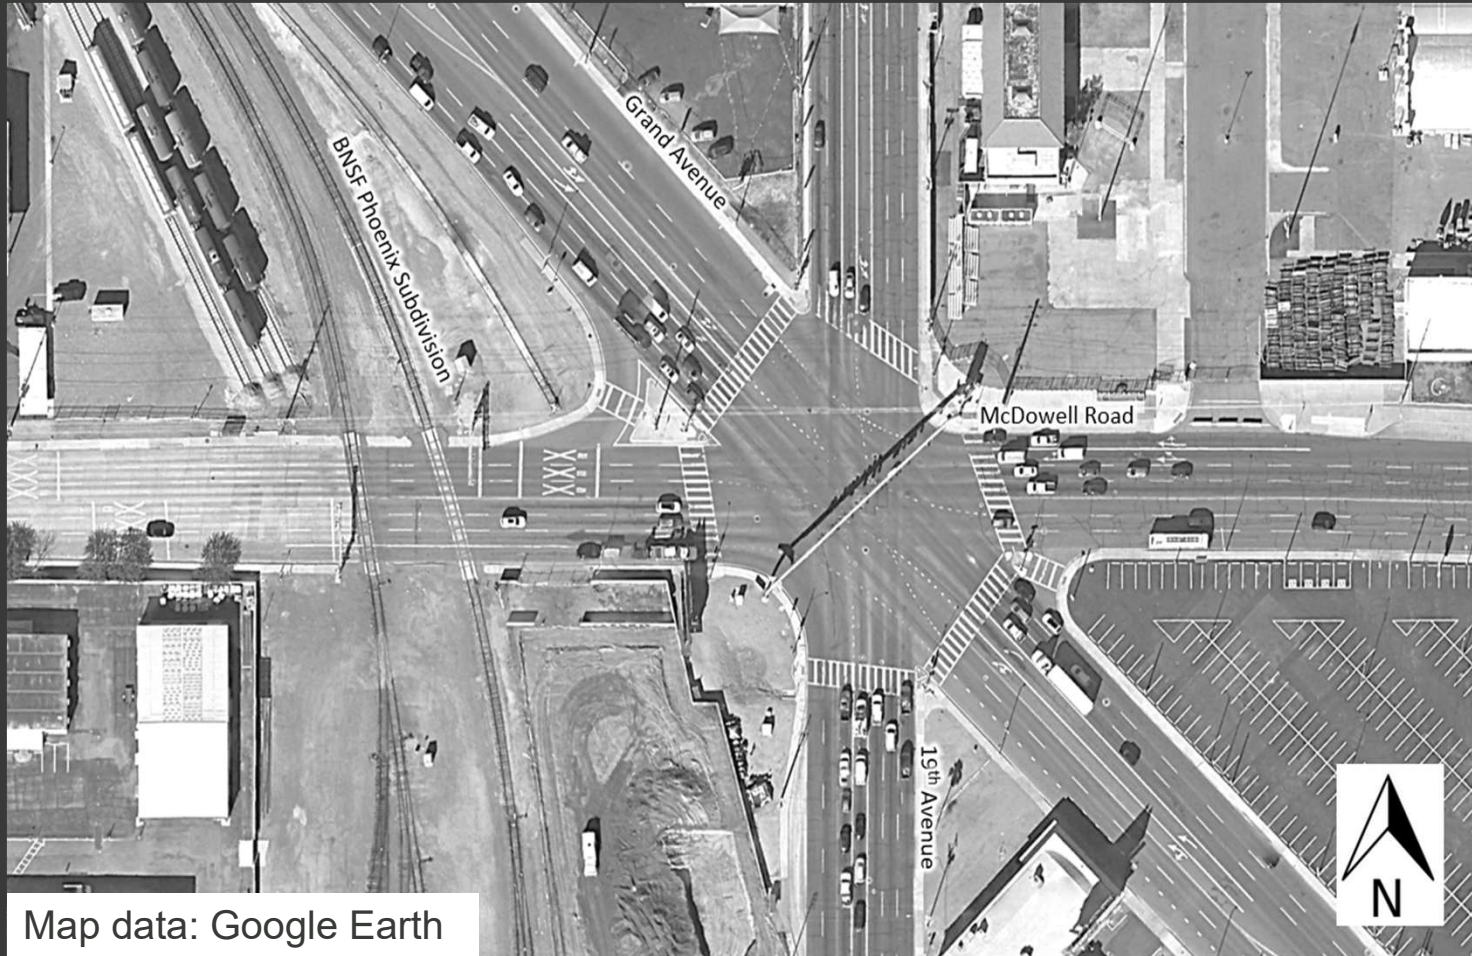
- AADT (Existing): 29,120
- 13% trucks
- Major bus transfer northeast of crossing
- Near state fair grounds
- Major intersection <200 ft downstream

- Daily Trains: 4
- Max Train Speed: 40 mph
- Regular train switching in area
- Blocked Crossings: 32
- FRA Reportable Incidents: 2
